12.3.8

SEASPAN 194 CAPSIZE

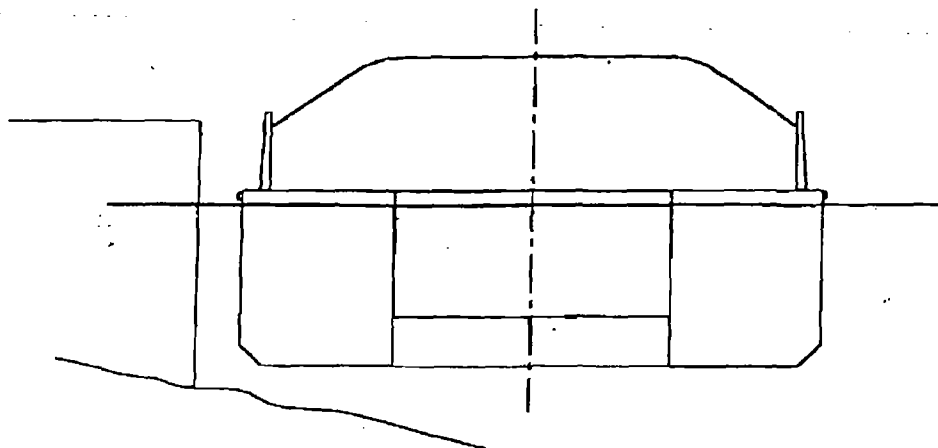
FIGURE 1

Figure 1 shows the barge as it arrived at the unloading dock. The mean freeboard was 14 1/2" as measured at the loading site. Freeboards at the unloading dock are not available. Corroded welds in the bottom plate in way of No. 1 centerline tanks has allowed water to enter this compartment over a long period. In effect, this compartment is tidal but air compression when the barge is loaded prevents the void filling to the loaded water line. When the barge capsized the water in this compartment was trapped. We have measured this water depth in the upside down condition so we know that 140 L. tons of water was on board at the time of capsize. This water was free to create a free surface effect and while not enough to capsize the barge in a free floating condition it did play a part in the course of events.

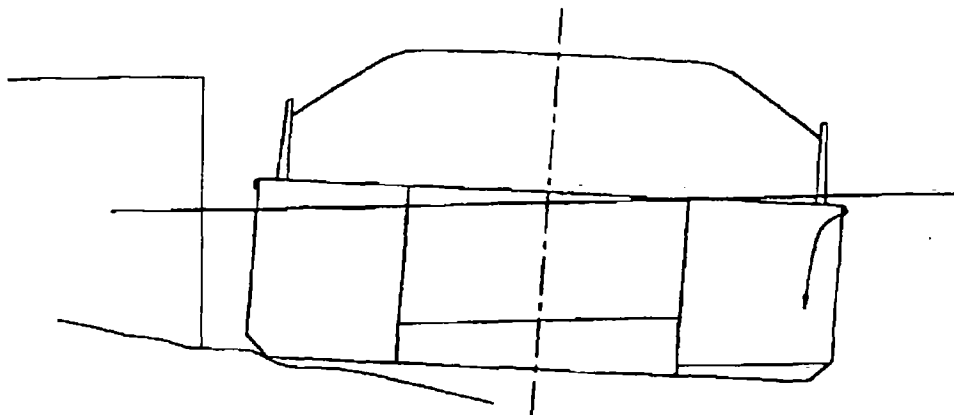
FIGURE 2

Figure 2 illustrates what happened during the first low tide. The barge grounded on the limerock berm lifting the port side and submerging the starboard deck edge. Sea water then flowed into No. 1 starboard void space continuously but at an unknown rate slowly filling the space. The free surface effect of water in No. 1 center space increased the list to starboard helping to submerge the deck edge.

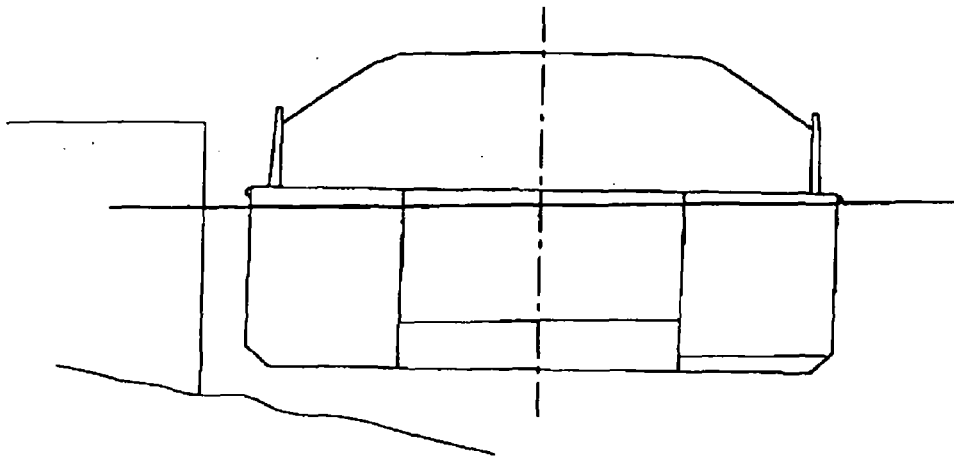
FIGURE 3

Figure 3 shows that when the tide came back in the barge port side lifted off the berm and the starboard side deck edge re-appeared above the water line. Water taken in to No. 1 starboard void space along with the free surface effect of water in No. 1 center tank ensured that the barge had a slight starboard list during the period of high water. The list would have been noticeable but not extreme.

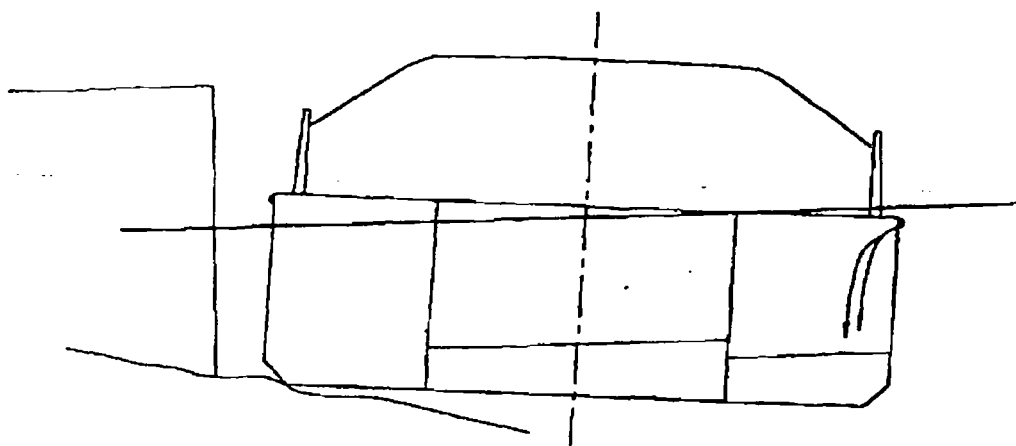
FIGURE 4

Figure 4 illustrates the return of low tide (2nd low tide). Again, the port side grounds on the berm lifting the port side and submerging the starboard deck edge. Water again flows into the No. 1 starboard void space increasing the list. As the list increases, again aided by the free surface effect of water in No. 1 center tank, hydrostatic head increases the water flow into the starboard tank.

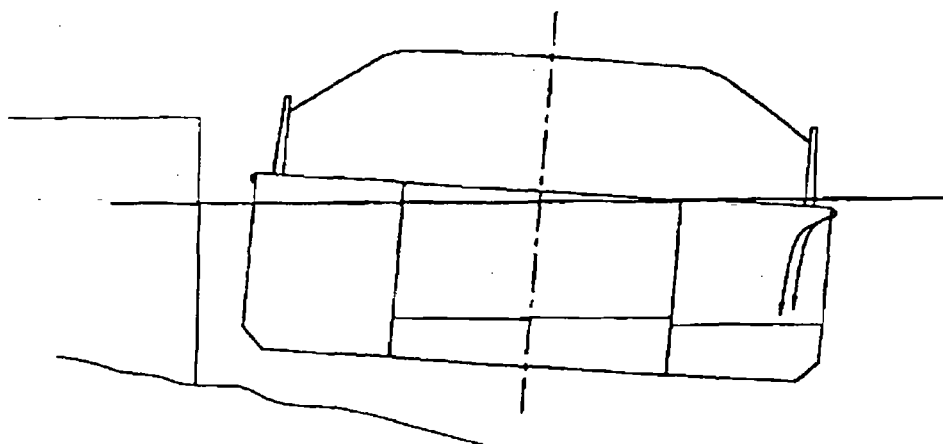
FIGURE 5

Figure 5 illustrates the return of high tide (2nd high tide). The port side floats free of the berm but there is enough water now in the No. 1 starboard void space (aided by free surface effect) to ensure that the starboard deck edge stays submerged. The void space continues to flood at an ever increasing rate as the list increases. The list would be at least 5° now and with the deck edge submerged the barge would be seen to be in danger by any observer.

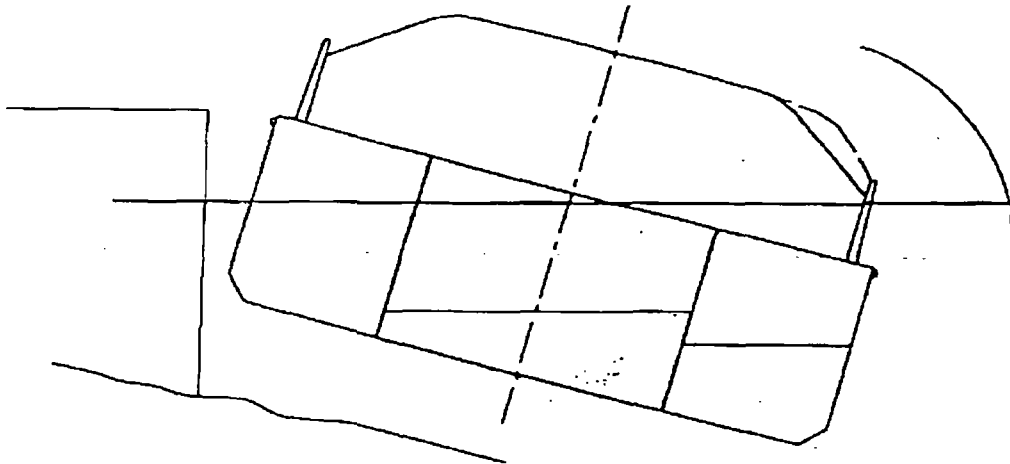
FIGURE 6

Figure 6 illustrates the final moments of the incident. The list increases to a point where either the barge loses stability due to lowering of the metacenter (lack of deck area) or the deck cargo shifts and moves to starboard. It must be remembered that the active free surface effect will exaggerate the effect of flooding in the starboard void spaces. The barge capsizes trapping the water in No. 1 centerline and blowing out the starboard box wall. The effect of the barge rotating and slamming down upside down moved the starboard box wall back inboard and the port box wall outboard. All this effect can be seen on the barge now in Vancouver Shipyards.
